**Confidential Inspection Report**  
**321 South Second Street**  
**Anywhere, NJ 08527**  
**Prepared for: Mr. Client Anyone**

**March 30, 2015**

**Report:** Sample Report **Address:** 321 South Second Street

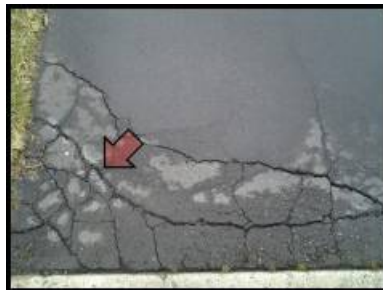
**Observations-** Cracks noted are major

**Recommendations-** Repair is needed by a qualified workman.

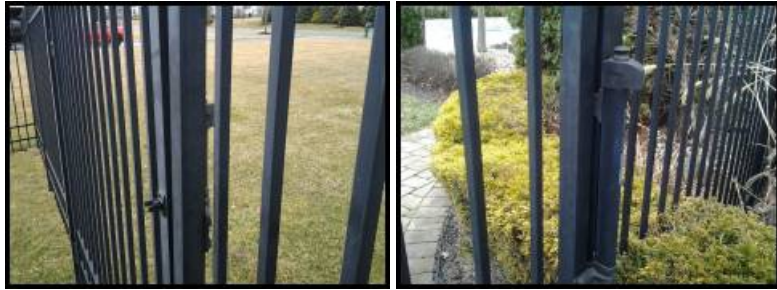
- (2) On the side of the gate closest to the swimming pool, with a release mechanism a minimum of five inches below the top of the gate. A gate meeting these specifications shall not have any opening greater than one-half inch within 24 inches of the release mechanism.

A licensed contractor, experienced in swimming pool fencing, should be called to evaluate the existing fence around the pool.

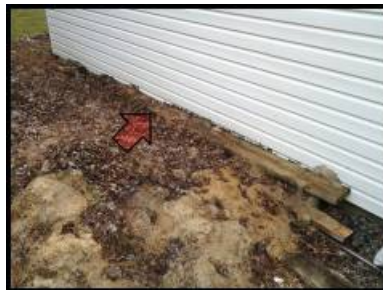
#### 3.1 Materials & Condition:

Siding on the shed is too close to grade. Wood and wood based products, stucco, fiber-cement, metal and vinyl should be at least six inches above grade. A qualified trim siding contractor should be called to make further evaluation and repairs as needed.

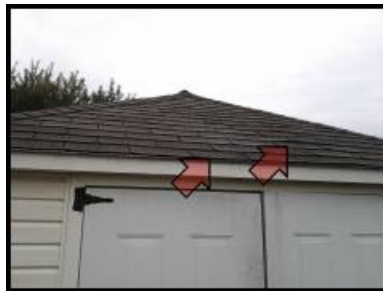
Shingles on the shed are curling and show a loss of their mineral granule coating. A licensed roofing contractor should be called in to make further evaluation and to repair or replace as needed.

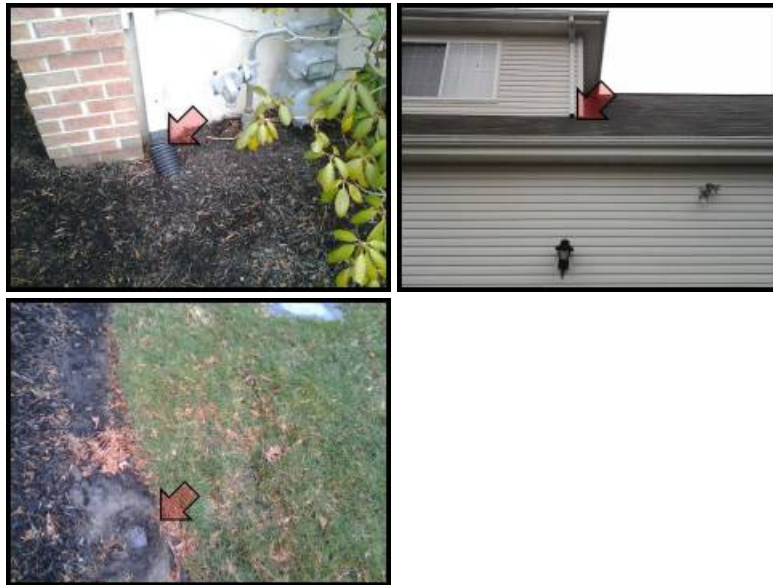
- 4.5 Type & Condition: Gutters and downspout materials are Aluminum. Subsurface drains noted, but Not Tested. THEY ARE NOT PART OF THIS INSPECTION.

Downspout is discharging on the roof, roofing shingles damage noted, an extension will prevent this section of the roof from deteriorating prematurely.

Puddling noted above the Subsurface drains. We were not able to determine if

the drain is clogged or damaged. Further investigation is required by a qualified contractor.

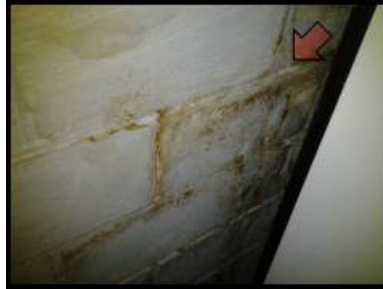
#### 5.3 Moisture:

Yes - Higher than normal moisture levels were noted on the exposed areas of the interior basement walls, and attention is needed to determine the cause and best cure. High moisture content in the exterior walls can lead to mildew and wood rot in high concentrations. The moisture content noted is high enough to cause either or both. Staining was observed: Water seepage may recur in the future. The best defense against water seepage is good drainage of soils near the foundation wall.

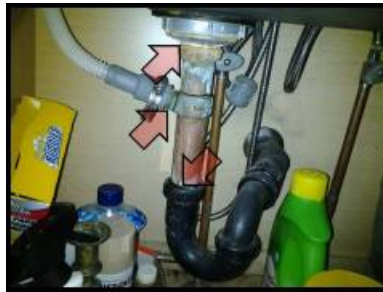
#### 6.1 Sink Drain:

The drain is leaking. Contact a licensed plumbing contractor for further evaluation and repairs as needed.

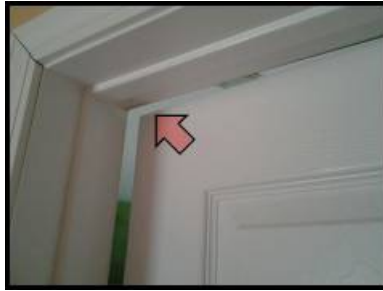
#### 7.1 Bedroom #2:

Doors rub/stick/won't latch. Door hardware needs some adjustment or repair for it to function appropriately.

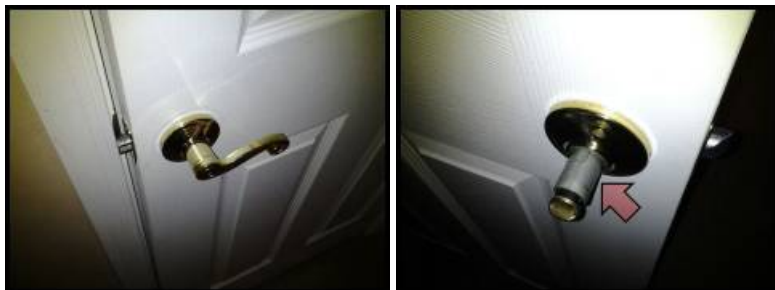
#### 7.2 First Floor Bedroom:

Doors rub/stick/won't latch, Door or its hardware needs repair or replacement. The doorknob assembly needs to be replaced.

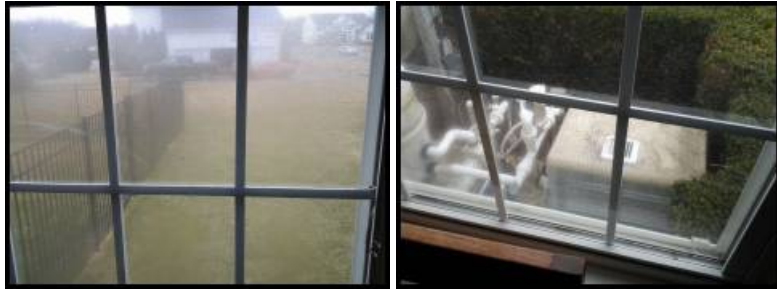
#### 7.3 General Type & Condition:

The thermal seal is broken on few windows. Although it is keeping the elements out, it has a clouded appearance. This condition will worsen. A licensed trim contractor should be called to make further evaluation and repairs as needed.

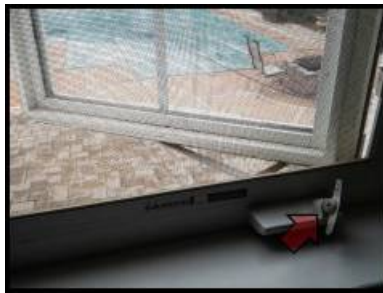
*7.4 Kitchen Interior:*

At least one window or associated hardware in this room needs repair. Locking hardware needs repair or replacement. A qualified trim carpenter should be called to make further evaluation and repairs as needed.

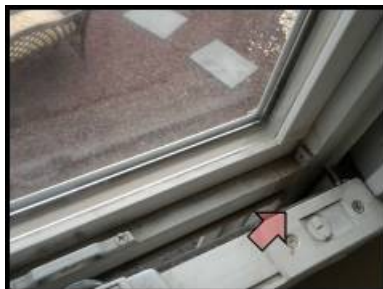
*7.5 Dining Room:*

At least one window or associated hardware in this room needs repair. The window frame is damaged. A qualified trim carpenter should be called to make further evaluation and repairs as needed.

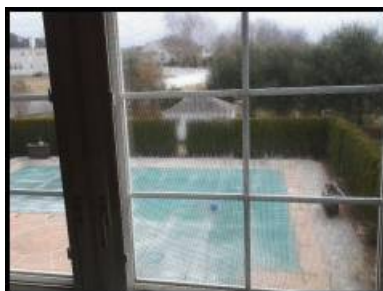
*7.6 Master Bath:*

At least one window or associated hardware in this room needs repair. The thermal seal is broken. Although it is keeping the elements out, it has a clouded appearance. This condition will worsen.

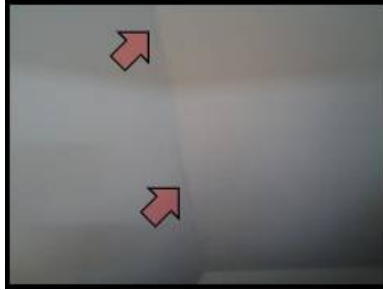
*7.9 Master Bedroom:* There is a condition in the ceiling that needs attention. Movement cracks were noted. Determination of the cause and repairs are needed.

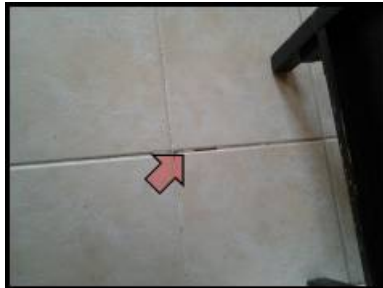
*7.10 Entry / Foyer / Hall:* The floor covering material is ceramic or glazed tile. Damaged grout noted. Repairs are needed.

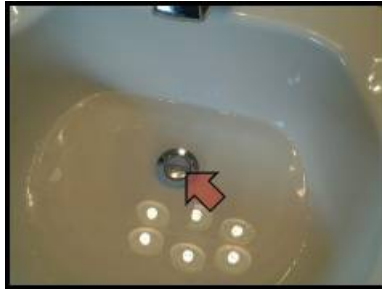
#### 8.1 Master Bath:

The following problems were noted at the drain: Drainage is a bit slower than normal. A licensed plumber should be called to make further evaluation and repairs as needed.

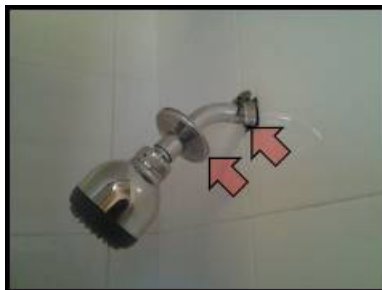
#### 8.2 Bath Between Bedrooms:

Condition of showerhead: Shower head is improper. Have a licensed plumber make proper repairs as needed.

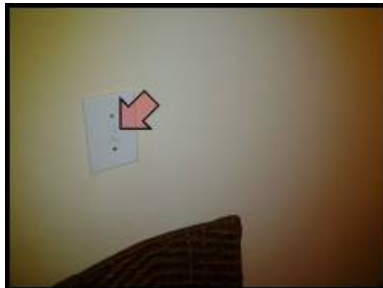
- 9.7 Basement: The installed 3 way switches are not wired correctly. Have a licensed electrician make further evaluation and corrections as needed.

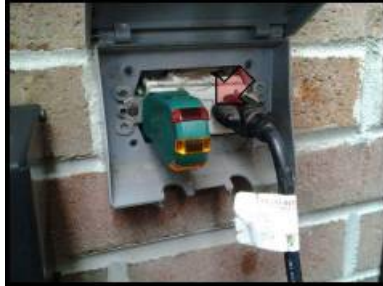
### 9.8 Exterior Walls:

GFCI is not operational at the front of the house. Have a licensed electrician make further evaluation and corrections as needed.

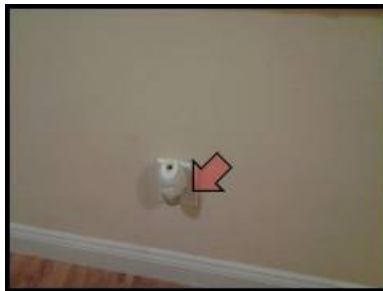
### 9.9 Basement:

Loose/Damaged outlets are viewed. Have a licensed electrician make further evaluation and corrections as needed.

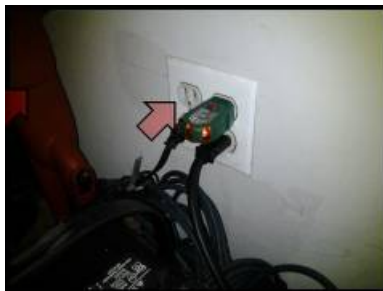
### 9.10 Garage Walls & Ceilings:

Ground Fault Circuit Interrupter (GFCI) outlets are recommended for installation at garage outlets. Have a licensed electrician make further evaluation and corrections as needed.

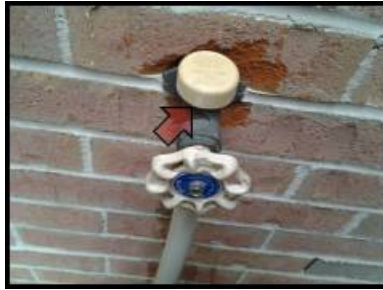
- 10.4 General:** An exterior faucet which leaked when operated should be repaired to avoid wasting water and to prevent moisture from accumulating next to the foundation. Even leaks which appear inconsequential can add significant quantities of moisture to the soil over time. Moisture in soil supporting the foundation can compromise the ability of the foundation to support the weight of the structure above. It can also cause foundation damage from heaving or settling, depending on soil composition and other conditions.

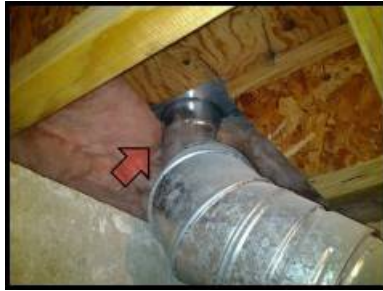
**11.5 Flues, Vents, Plenum:**

Inadequate vents clearance- Combustibles are nearby. Move the insulation away from the vent connection.

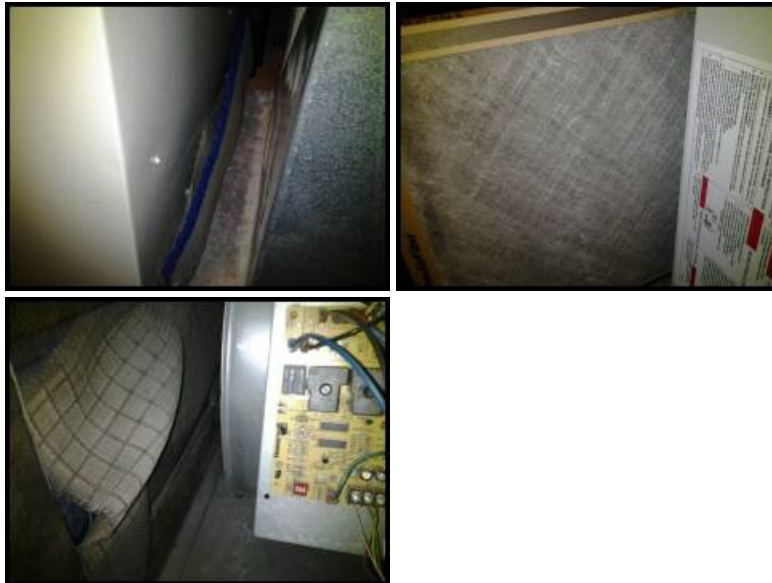
**11.6 Air Filters:**

Matt type cut to fit. The filter is in need of cleaning or replacement. Replacing or cleaning filters every 30 to 45 days is recommended. Contact a licensed heating contractor for further evaluation and repairs as needed.

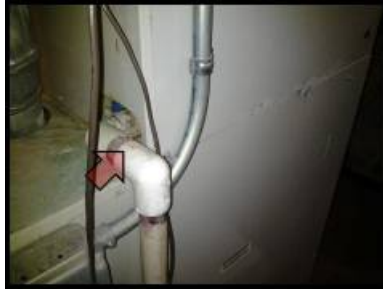
### 11.10 Condensate Line:

The condensate trap is missing. The primary purpose of a condensate trap is to prevent air from moving in or out of the coil box or air handler during operation. Traps must be installed in a manner that will stop the air from passing through, but still allow the condensate to drain from the condensate pan. Further evaluation and repair or replacement will be needed by a qualified air conditioning contractor.

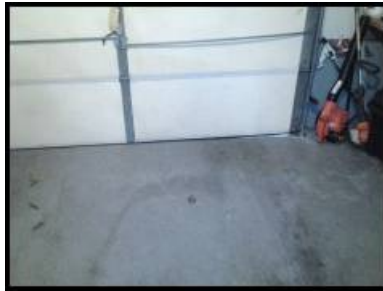
12.3 Automatic Opener: Automatic reverse feature is not operational. Note: All overhead doors should have fully operational auto-reverse function. and Door opener tension needs adjustment however, to insure safe conditions.

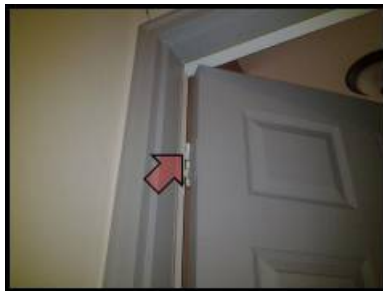
### 12.4 Service Doors:

For safety reasons, there should be a door check installed. A device, usually hydraulic or pneumatic, for controlling the closing of the door and preventing the toxic fumes from entering the living space.
